A large Griffin Van de Graaff generator (VdG), sometimes known as the Griffin Senior, (Fig. 1) was brought to us for testing, the school being concerned that it could be capable of producing a dangerous spark from the dome having read SSERC Bulletin 223¹.

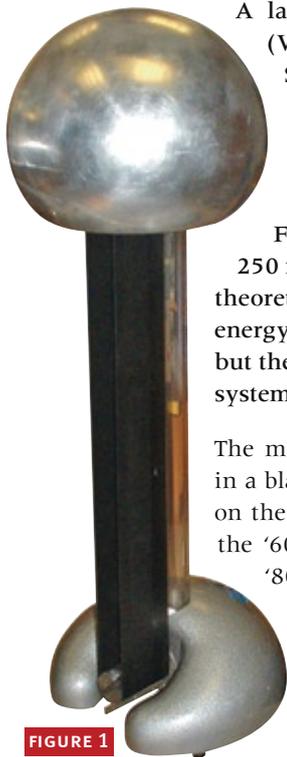
From the size of the dome, about 250 mm diameter, the machine is indeed theoretically capable of storing 1.0 J of energy, which could be rather dangerous, but the greater danger is the mains electrical system.

FIGURE 1
GRIFFIN SENIOR VAN DE GRAAFF GENERATOR WITH SPEED CONTROLLER.
PRODUCT CODES: L81-280, THEN XJE-400.
OVERALL HEIGHT = 760 MM. DOME DIAMETER = 250 MM.

Apparatus with multiple faults such as these above should be taken out of service and either disposed of and replaced, or re-conditioned. Replacement is much the better option. Think of the image you present to the kids every time you produce apparatus like this VdG, designed in the '60s. The main problem with reconditioning the apparatus is that the job must be done competently. There is a significant chance that repairs, however well intentioned, might result in other dangers.

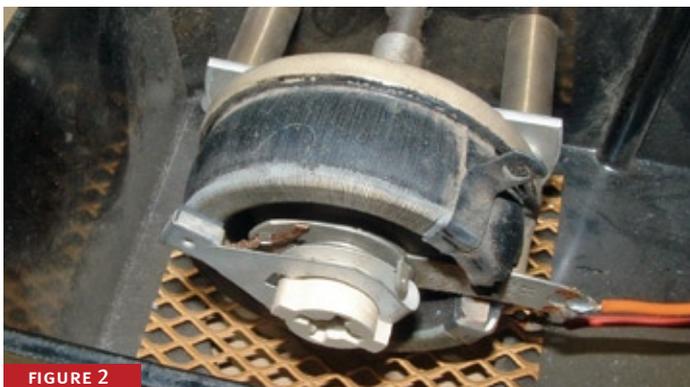
The 3-wire mains cord from the 13 A plug goes via the speed-control box to the VdG motor. Within the speed-control box there is a large wire-wound variable resistor which is in series with the motor on the phase-live supply line. Above and below the variable resistor are large circular apertures in the Bakelite panels, top and bottom, covered by wire mesh. The following hazards were found:

- The size of mesh is too large. (> than 1 mm) (Fig. 2).
- If the mesh is depressed, it can touch the wire windings on the resistor, which are live at 230 V a.c. (Fig. 2).
- The meshes are unearthed (Fig. 2).
- The power connector between the control box and VdG is a 3-pin Bulgin plug (Fig. 3). This has unshrouded pins at mains voltage which can be opened easily by hand and does not adequately provide strain relief on the cord.
- The VdG base is not connected to the protective earth conductor. Whether this is by design or as a result of a fault condition, we did not have time to find out.

FIGURE 2
WIRE-WOUND RESISTOR IN SPEED CONTROLLER WITH CIRCULAR APERTURE IN BOTTOM PANEL COVERED BY WIRE MESH.
