‘Gauzegate’

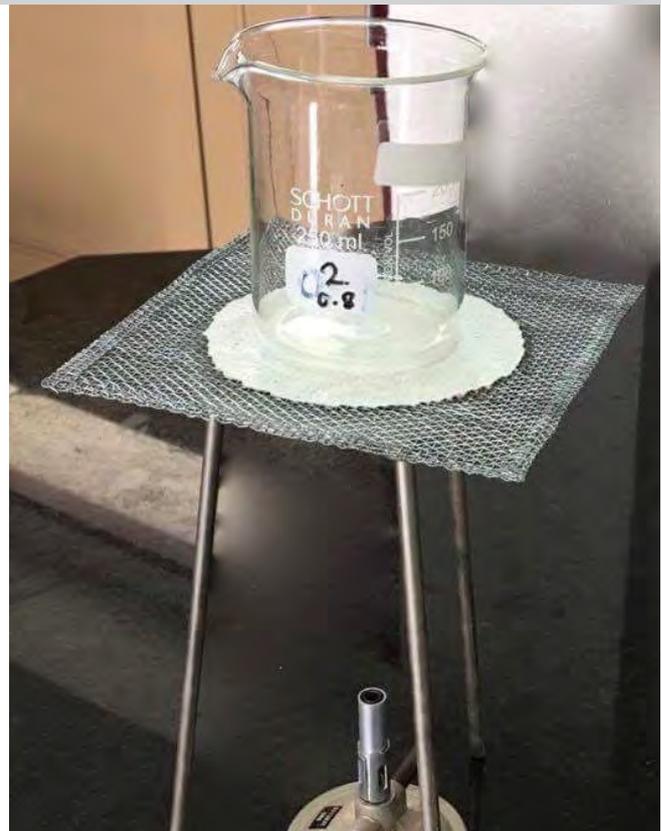
Figure 1 - Bunsen gauze (Image by NagayaS (CC BY-SA 4.0)).

Any gauzes should be carefully double-bagged and kept for disposal by a licensed asbestos contractor. HSE say that any other gauzes in the same tray/cupboard, even if they are plain metal, should also be disposed of.

Apart from these, **there is no need to dispose of any other equipment stored with the gauzes**. Tripods, Bunsens and the like should simply be wiped down with a damp cloth and the cloth disposed of along with the gauzes.
